## Histologic Analysis of a Failing Three-Part Dental Implant: A Human Case Report

*Two failing implants were removed for prosthetic reasons from the maxilla of a 60-year-old woman. The implants were clinically immobile but presented clear signs of peri-implant mucositis and bone destruction. One of the two implants was harvested together with the surrounding bone and analyzed histologically. The implant was threaded and consisted of three distinct components screwed together in a telescopic fashion. Histologically, bone loss reached the fourth thread, while apical to the fourth thread, osseointegration between the host bone and the implant surface was recognizable. The implant parts were not completely seated into each other, and the resulting gap was colonized by host bone. Newly formed alveolar bone penetrated deep into the implant body cavity and appeared similar in nature to the alveolar bone surrounding the implant. Histologic findings are discussed in reference to the ability of such an implant to withstand biomechanical loading over time. (Int J Periodontics Restorative Dent 2005;25:615–621.)*

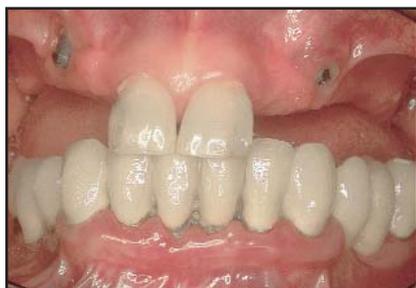
**Fig 1** Clinical view of the patient at the time of initial consult. Note the buccal implant positioning, with soft tissue dehiscence particularly evident at the maxillary left canine.

A 60-year-old female patient in good medical condition presented in our clinic complaining of pain during chewing underneath the existing maxillary removable partial denture. Clinically, two implants, not connected to the removable denture, were present in the positions of the maxillary right and left canines (Fig 1). We were unable to obtain any information regarding the implant manufacturer or the patient's past dental history. Radiographically, the implants appeared to be root-form

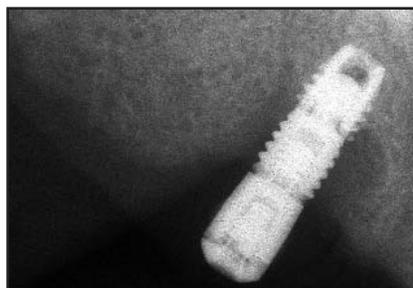
**Fig 2a** The maxillary right canine implant. Bowl-like peri-implant bone loss is radiographically detectable. It is also possible to observe the original design of the implant. The coronal part is constituted by a smooth collar that is screwed into a threaded middle part. The middle threaded part is then screwed into the apical part, which is threaded and tapered.

threaded screws consisting of three parts (Figs 2a and 2b). The two most apical components were threaded, while the coronal component was smooth. Both implants presented with a clearly recognizable bowl-like area of crestal bone loss; however, the bone defect was more advanced at the implant in the maxillary right canine position than at the contralateral implant. Clinically, the implants were characterized by the presence of buccal soft tissue dehiscence, with signs of inflammation of the peri-implant mucosa. The peri-implant area was very tender and

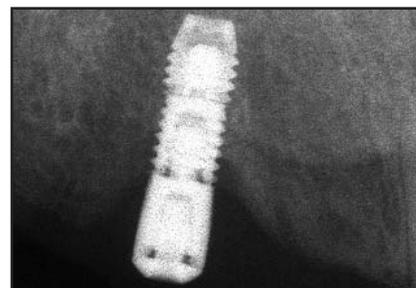
**Fig 2b** The left canine implant. Less advanced crestal bone loss is evident around the implant. The bony defect reached the fourth thread of the implant, but no peri-implant radiolucency can be seen along the implant body.

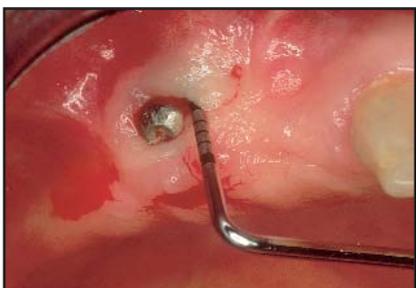
**Fig 3** Probing at the right canine implant. The probing depth is 10 mm buccally. Upon probing, bleeding and drainage of exudate could be seen.

bled easily upon light palpation and probing. Peri-implant probing around the right canine implant showed a 10-mm pocket depth (Fig 3), while the left canine implant had a probing depth of 6 mm on the buccal side. Nevertheless, both implants were clinically immobile. According to the patient, the implants had been placed about 2 years before in a submerged fashion. The implants had never been surgically uncovered and connected prosthetically, but they had been exposed to the oral cavity, probably because of tissue compression and friction from the removable partial denture. Because of the unfavorable buccal position and direction of the implants and the

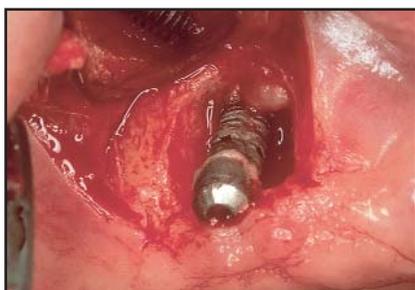
**Fig 4** A mucoperiosteal trapezoidal flap is raised at the right canine implant. The granulation tissue is removed. Note the advanced bone resorption circumferentially and the contamination of the implant surface by bacterial plaque. The implant was clinically immobile.

ferential defect was present around the right canine implant (Fig 4). At the left canine, the coronal smooth part and the four most coronal threads beyond the smooth portion of the implant were exposed buccally (Fig 5). At this point, the implants and the attached surrounding bone were harvested with a 4-mm-diameter trephine bur under copious irrigation. The left canine implant was harvested intact (Fig 6). The block specimen was rinsed with sterile water and immediately immersed in a 10% paraformaldehyde fixation solution. The surgical socket was filled with a collagen sponge (Spongostan Dental) and the flap was sutured with silk to achieve primary closure.

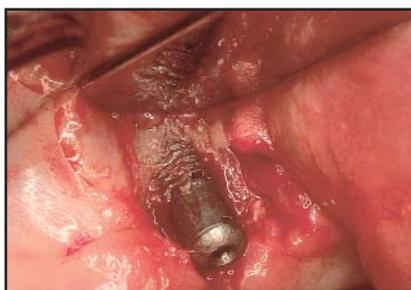
**Fig 5** The left canine implant after flap elevation. A bone dehiscence reaching the fourth thread of the implant confirmed the radiographic evidence shown in Fig 2b.

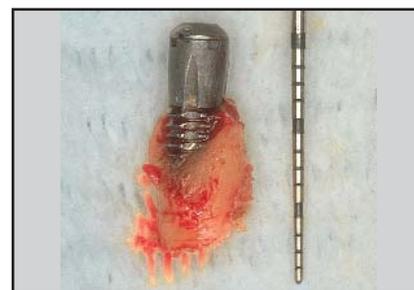
**Fig 6** Block specimen of the left canine implant after harvesting together with surrounding bone. It is possible to observe the bone dehiscence buccally.

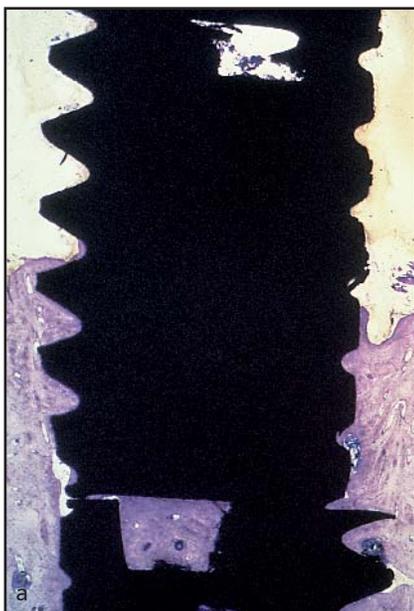
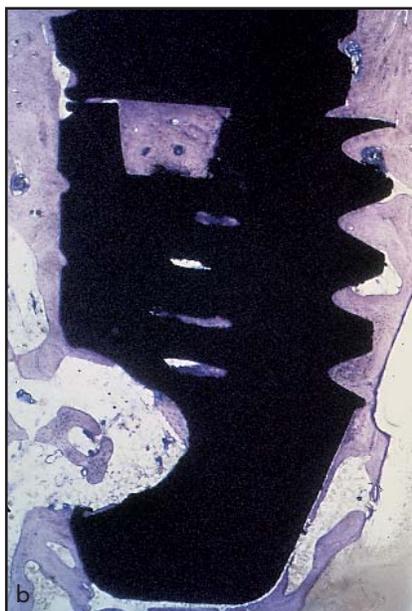
**Fig 7** Low-power views of the histologic preparation. The implant design, as it has been described radiographically, is evident. (a) Coronal portion of the implant, with threads that are no longer surrounded by bone. (b) Apical portion of the implant. Good bone-to-implant contact seems to have been established at this magnification (toluidine blue; original magnification  $\times 40$ ).

At low-power magnification, it was possible to clearly view the implant design. The implant consisted of three components screwed into each other (Fig 7). The central and apical parts of the implant were threaded and lightly tapered toward the apical zone. The tips of the threads appeared to be rather blunted and irregular (Fig 8). The coronal section of the implant consisted of a long smooth collar screwed into the middle implant component. Bone loss at the most coronal area was visible. The alveolar bone loss stopped at the level of the fourth thread (see Fig 7a). At a higher magnification, the rela-

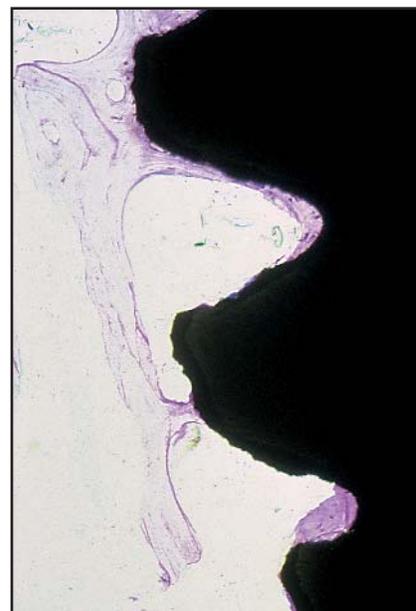
**Fig 8** High-power view of the implant threads. The tips of the threads are rather blunted and the surface appears irregular (toluidine blue; original magnification  $\times 200$ ).

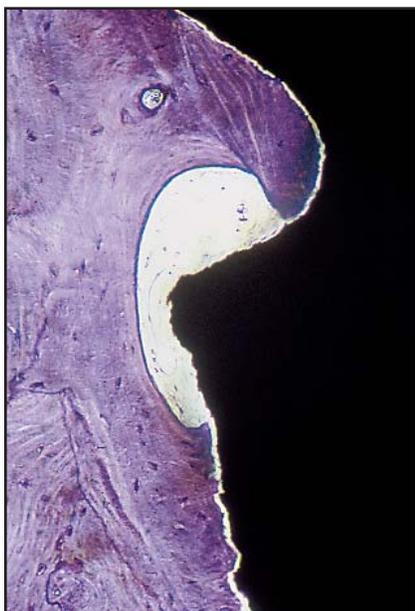
**Fig 9 (left)** High-power view of the bone-to-implant contact. A marrow space faces the tip of a thread. A gap between the alveolar bone and the implant surface is evident and may be interpreted as an artifact of histologic processing. Note the perfect correspondence between the implant surface and the bone profile (toluidine blue; original magnification  $\times 200$ ).

tionship between the bone and the implant surface could be seen to be characterized by a rather homogenous microgap along the entire perimeter of the implant (Fig 9). This very thin, homogenous gap accurately reproduced the implant surface topography. The absence of any fibrous tissue or staining between implant and bone, along with the clinical stability of the implant at the time of harvesting, led us to consider this, in accordance with others,<sup>8</sup> as an artifact of the histologic manipulation of the specimen rather than a lack of osseointegration. The peri-implant alveolar bone was mature and lamellar in nature, with osteocytes populating the visible lacunae and

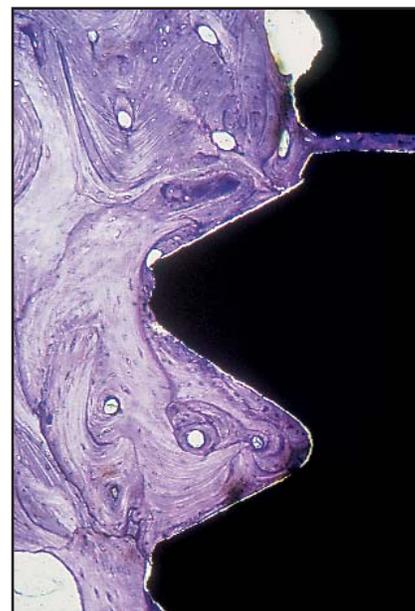
**Fig 10 (right)** Bone-to-implant contact is rather homogenous along the entire implant perimeter. The alveolar bone appears highly haversian in nature. Lamellation and secondary osteons are visible in the area between the implant threads (toluidine blue; original magnification  $\times 100$ ).

very limited marrow spaces. Secondary osteons could also be seen around the peri-implant bone tissue (Fig 10). Interestingly, the two most apical implant components

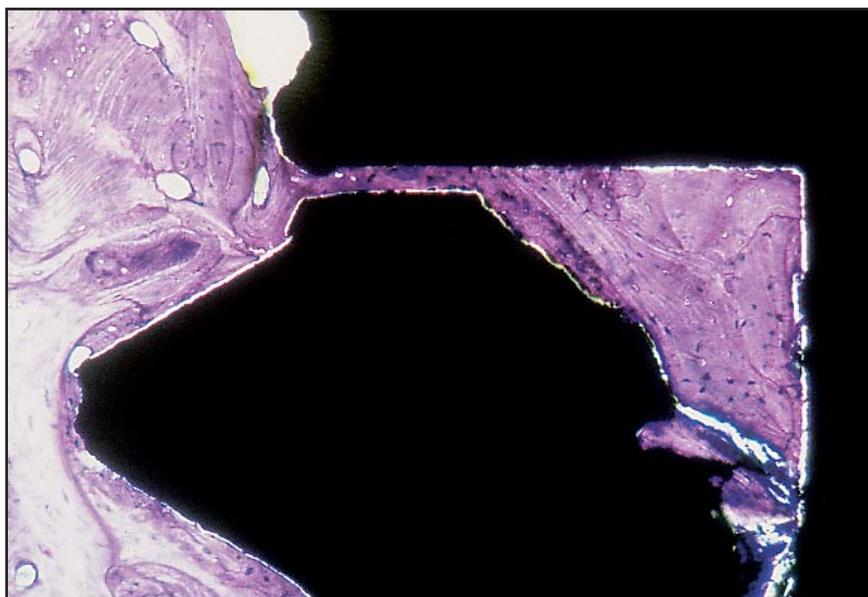
**Fig 11** Area of discrepancy between the middle and apical implant components. Alveolar bone is creeping through the gap to reach the implant cavity. Newly formed bone in the implant cavity shows the same histologic characteristics as the surrounding alveolar bone (toluidine blue; original magnification  $\times 200$ ).

were not completely seated into each other. The resulting gap was partially obliterated by host bone that migrated into the implant body (Fig 11). The bone created in this

appearance of a peri-implant lesion.<sup>13</sup> Interestingly, we noted that implant parts failed to achieve a perfect fit. The gaps between the implant components were filled by lamellar bone and marrow spaces. Newly formed bone penetrated inside the implant body cavity through the microgap. This observation deserves some consideration. A precise fit of prosthetic restorations is essential to maintain prosthetic stability and osseointegration over time. Misfitting components may cause abutment fracture. However, an even more detrimental effect of component misfit is a non-physiologic distribution of loading stresses into the surrounding bone.<sup>14,15</sup> In the present case, the implants, although never prosthetically connected, may have received some load, because they were uncovered and overlaid by a complete denture.
